Long-run resilience in the energy & water sectors

NEW PIN Workshop
22 June 2016

Introducing Electricity North West

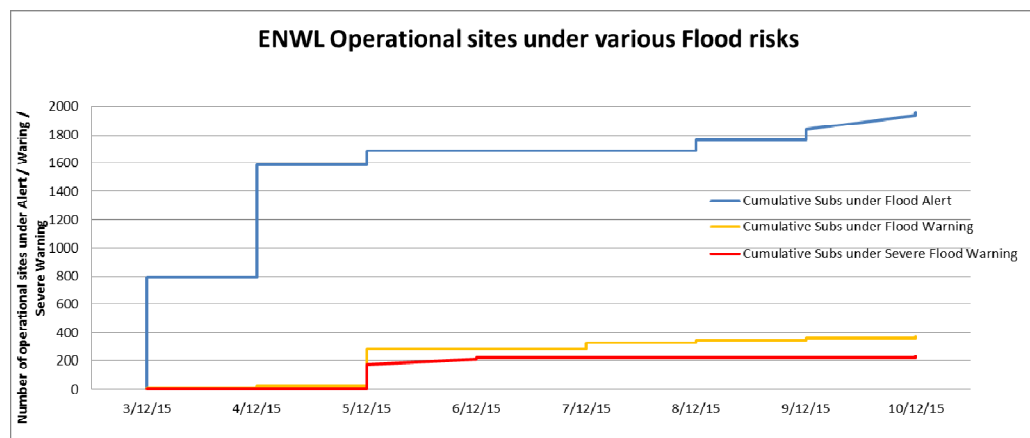
48 Hour UK Rainfall Total 0900 4th December – 0900 6th December

Site Name	Area	Rainfall Total mm
Shap	Cumbria	262.6
Keswick	Cumbria	178.4
Blencathra	Cumbria	174.8
Capel Curig	Gwynedd	170.6
Tyndrum	Perthshire	141
Eskdalemuir	Dumfriesshire	139.2

- Rainfall exceeded previous 24 and 48 hour records.
- Exceeded 300mm locally.
- Rain fell on saturated hills causing rivers to ‘flash’
- River levels spiked beyond EA models
- EA Alerts, Warnings and Severe Warnings covered some 2,500 ENW operational sites
- Severe Warnings (danger to life) covered over 200 sites.

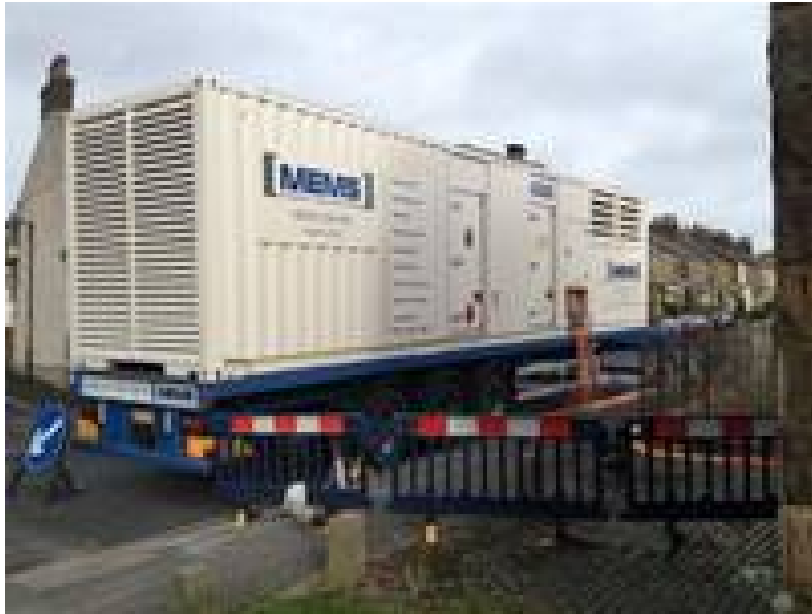
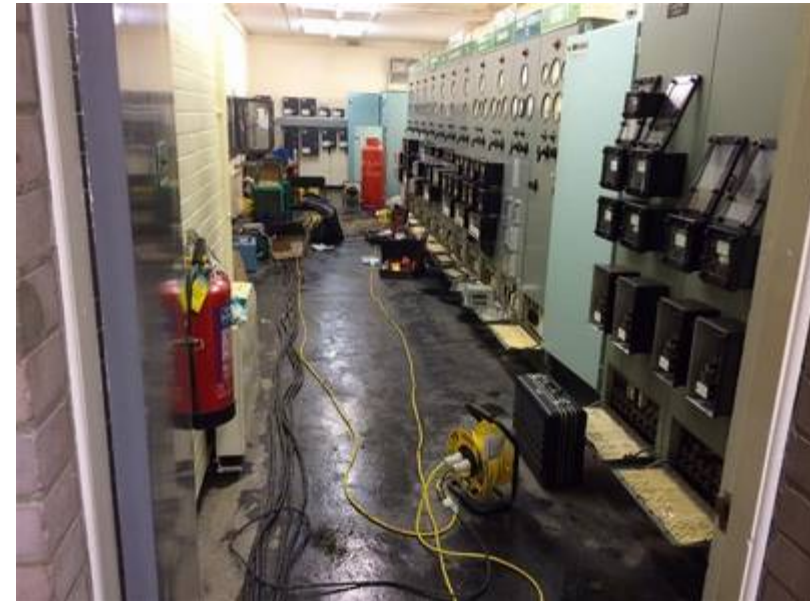
Lancaster Grid 1

- Severe flooding of River Lune adjacent to Lancaster Grid
- High volume pumping and installation of additional defences unsuccessful
- Defences overtopped - Supplies lost to 60,987 customers by 22:39 on 5/12
- Flooded assets - both 33kV switchboards, A and B section busbars, protection systems, batteries, SCADA and auxiliary wiring and control systems
- 75 >500KVA generators connected restoring 22,000 customers
- Access to site noon 6/12
- GT1 restored 04:28 on 7/12 with most customers restored shortly after, generators left in situ. Final restorations 15:30 on 7/12

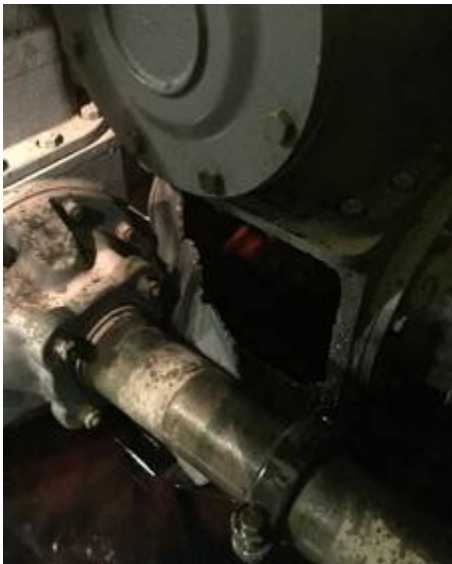
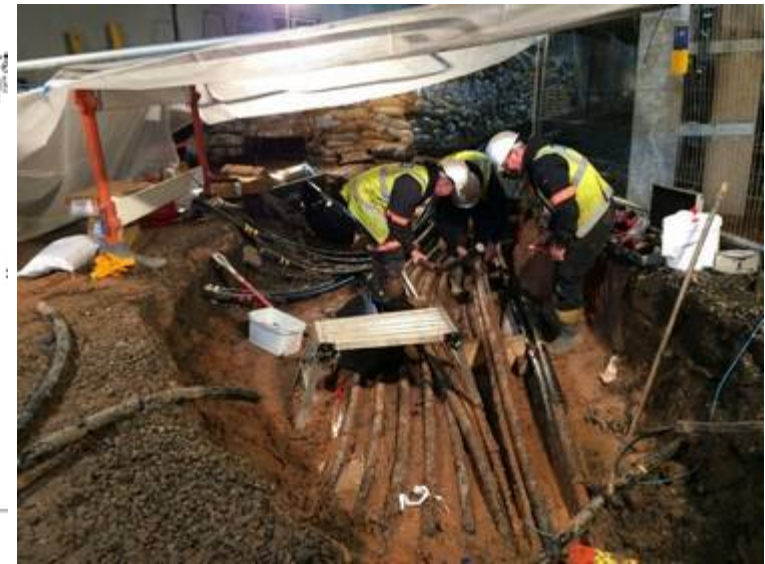
Lancaster 2

- 15:56 on 7/12 fault on section A busbar in the GT1 busbar connector interrupting 45,525 customers
- Catastrophic failure of GT1 section A link chamber due to water ingress into the resin oil – confirmed by EATL
- Section A un-repairable - all work now focused on GT2 and sections C and D
- Extensive emergency jointing, including associated control systems
- Supplies restored successively. Final restorations at 19:18 on 8/12

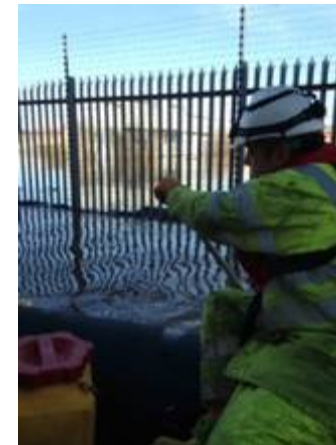
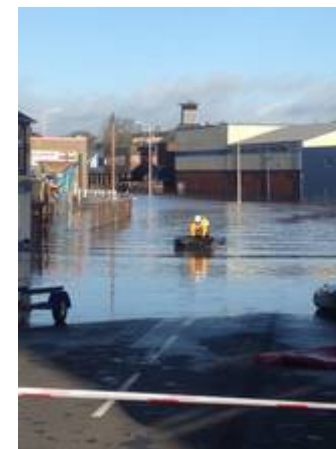
Willowholme Primary substation, Carlisle

- Site immediately adjacent to the Environment Agency's River Eden defences and relies on those defences in line with ETR138
- Willowholme Primary substation site was flooded to a depth of more than 1m exceeding 1:100 and 1:1000 (2010 forecast) depths
- 11kV switchboard submerged to a depth of 1.5m
- Additional temporary defences including door seals, sand bags and pumps did not prevent loss of site. Supplies lost 08:37 on 6/12
- Access to the site only possible by boat and access to the switch house only possible through roof apertures
- Majority of customer supplies were restored from adjacent network feeders
- Small number of customers – mainly industrial/ commercial – remained off (many flooded)
- Site restored 09:46 on 15/12

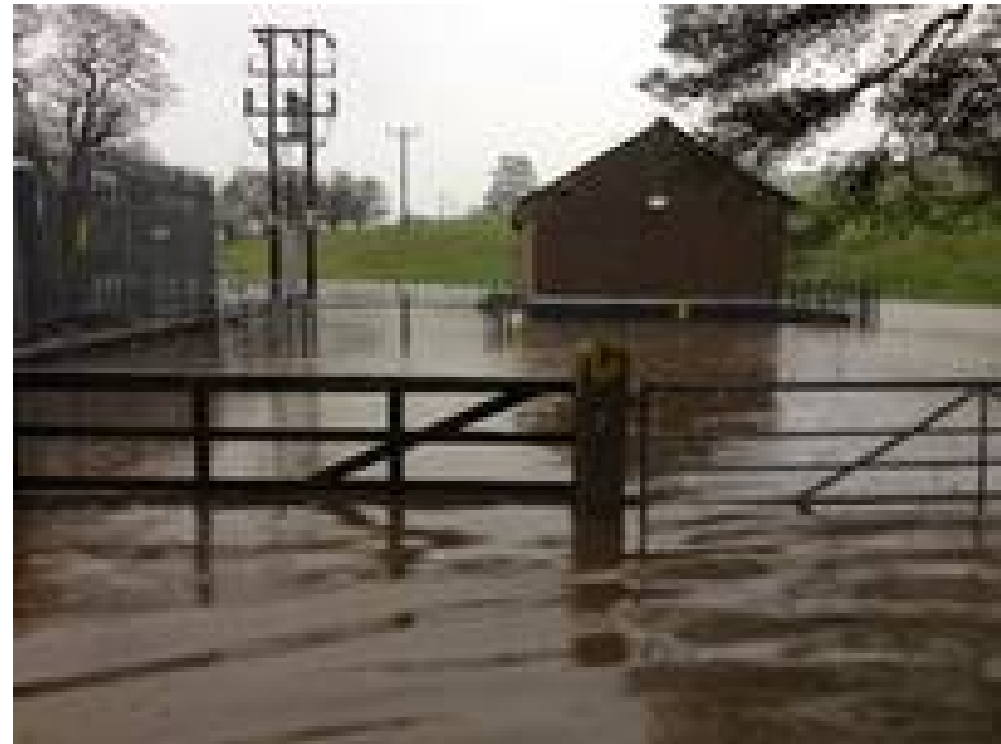
Melling Primary Substation

- 1.29m Flood defences overtopped
- Protected to 1:1000
- RC used to supply majority of 1,096 customers via HV interconnection from Keswick
- Remaining customers off until repairs completed 07/12/15 (2 days later)
