Appendix - Storm Eva

26/27 December 2015

Storm Eva Rainfall

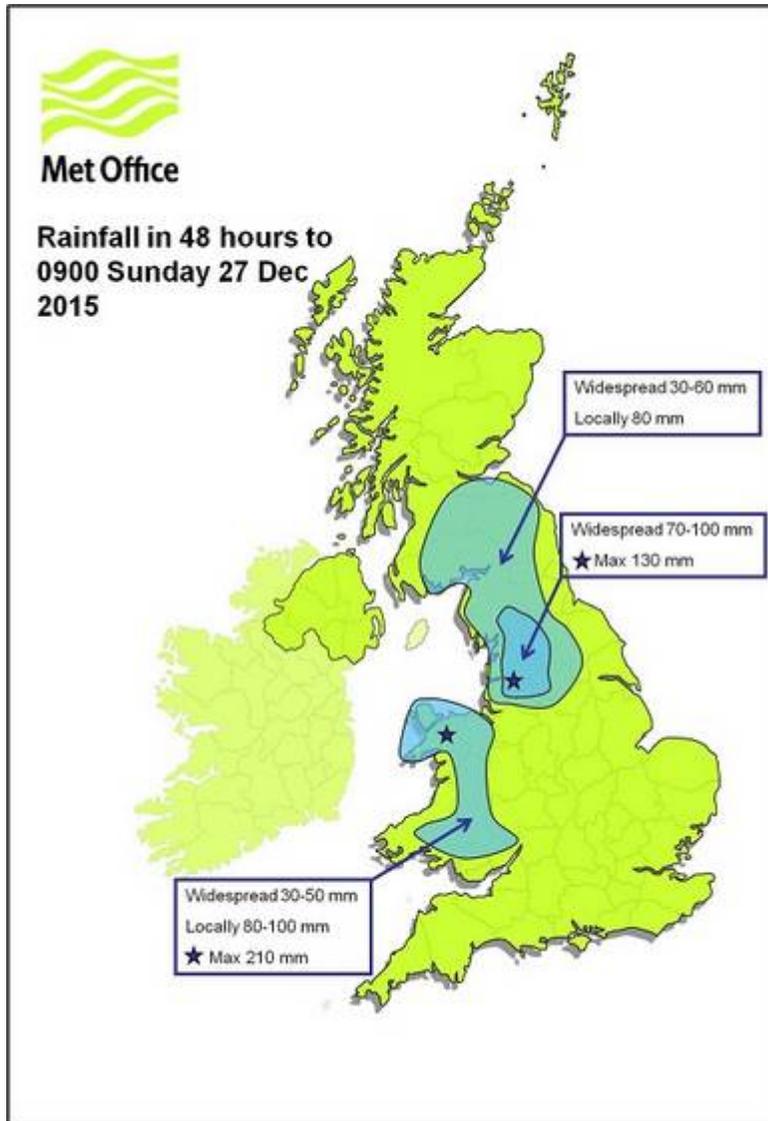
48hr UK RAINFALL TOTALS 9am 25 DEC – 9am 27 DEC 2015

SITE	AREA	RAINFALL TOTAL (MM)
STONYHURST	LANCASHIRE	100
SHAP	CUMBRIA	86.4
SPADEADAM	CUMBRIA	79.4
PRESTON, MOOR PARK	LANCASHIRE	73.2
MYERSCOUGH	LANCASHIRE	72.4
ROCHDALE	GREATER MANCHESTER	68.2

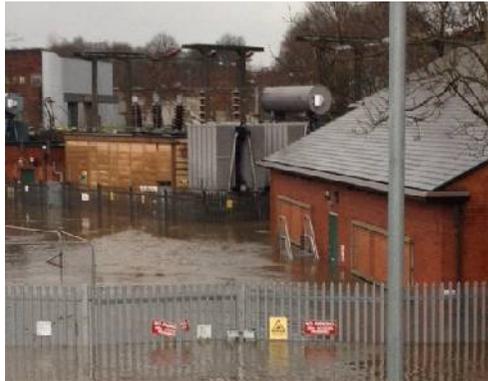
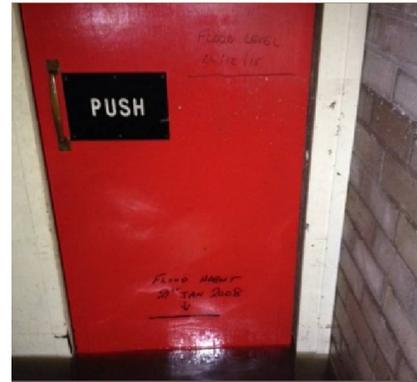
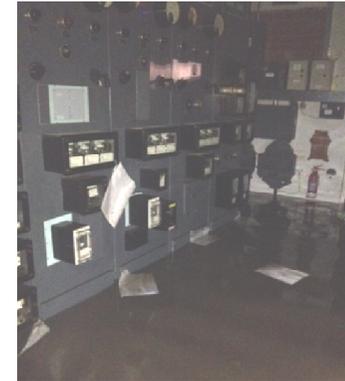
Dane St Primary (Rochdale)

- In same grounds as the grid site
- Floods reached 1.5m high inside the control room of the substation
- 6.6kV switchgear – completely engulfed just below busbar spouts. A and B sections did not have water penetration to busbar or CT chambers, C and D had busbar and CT chamber cable box breaches. 6.6kV protection panels engulfed
- At peak 28/12, 11:12, 25 generators had been connected restoring 31 substations supplying 5,689 customers.

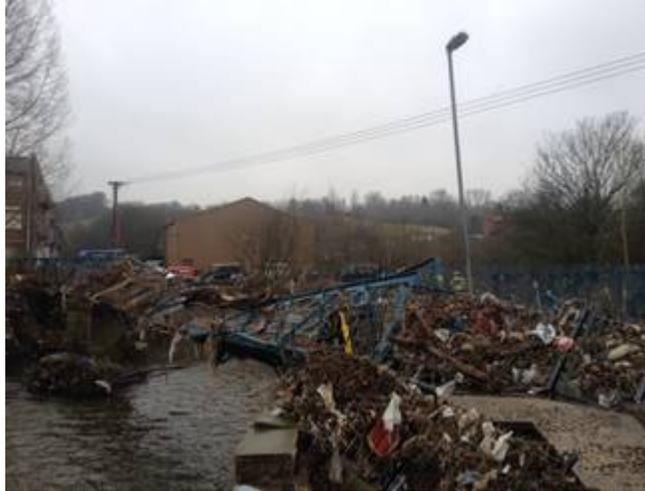
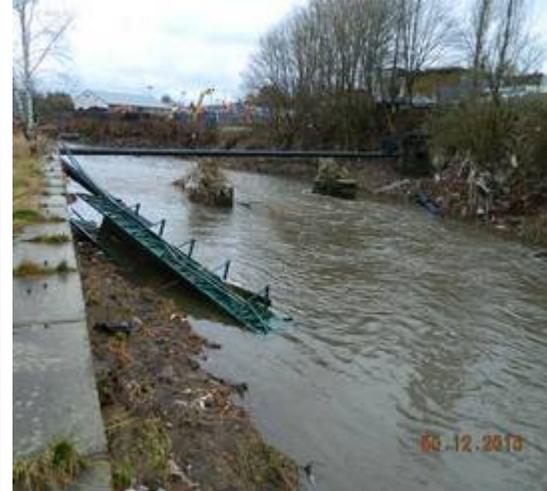
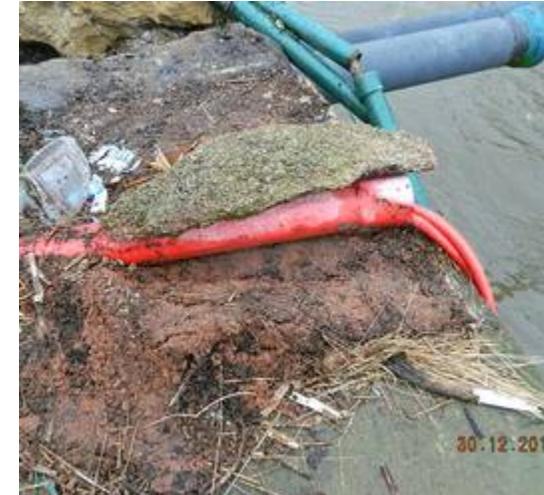
Loss of Cable Bridges across Irwell - Bury

- Two locations affected by cable bridges each spanning the Irwell and each carrying two HV circuits
- <https://www.youtube.com/watch?v=Mb4HPYSSv8U>
- **Location 1: Milltown street**
- Milltown Street cable bridge had suffered severe damage, is unstable and needs replacing. It was still carrying one live 11kV and one live 6.6kV circuit when discovered. The 6.6kV was damaged and was replaced with a span of overhead line
- Council owned footbridge bridge – awaiting plan from council but unsure if replacing
- **Location 2: Lomax st**
- Lomax Street was a pedestrian footway which has been completely washed away.
- It was carrying two 6.6kV cables. Both of which have had to be abandoned until cable bridge is reinstated.
- United Utilities strategic sewer works also required and bridge rebuild expected 6-12months time.
- 5 substations still on a radial HV span until the bridge is rebuilt

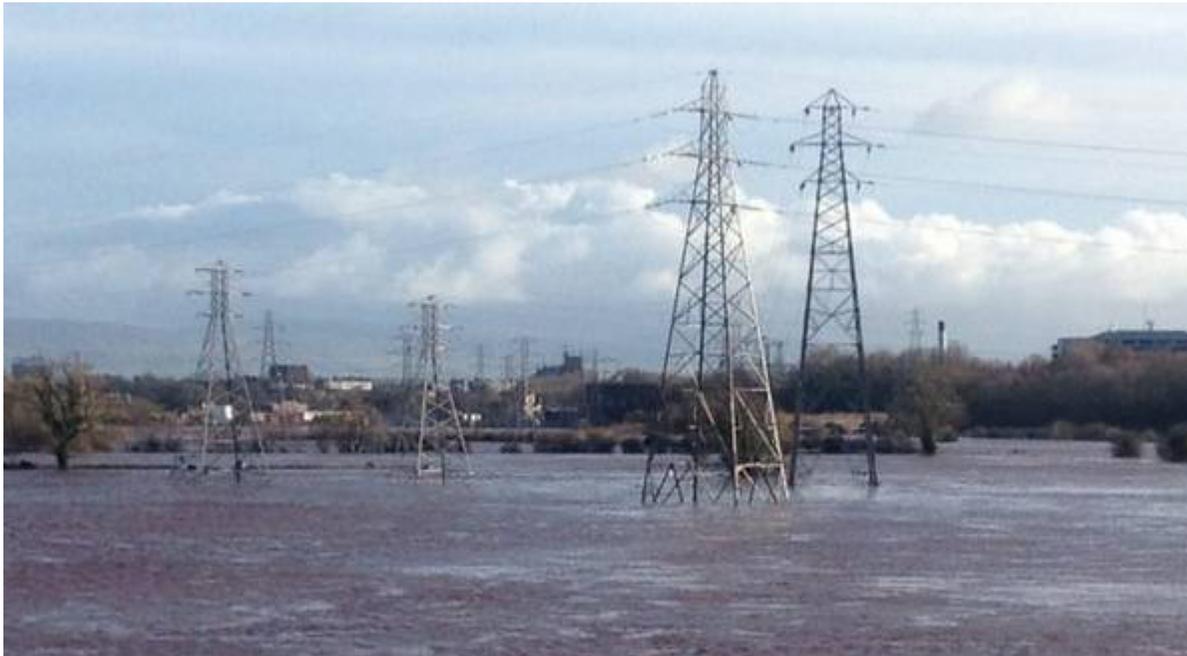
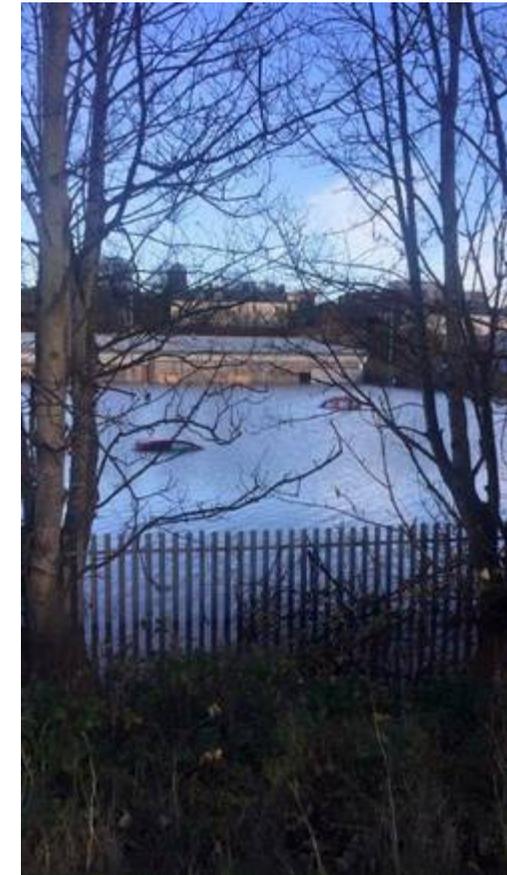
Desmond – Carlisle BSP

- Carlisle BSP was flooded to a depth of 1m, versus 1.05m 1:1000 defences
- Permanent defences reinforced, high volume pumps from Fire Service
- Site inaccessible even with Unimog vehicles
- At one stage lost 2 of 3 GT on site – preparations made for rota shedding
- Several short duration interruptions as network reconfigured

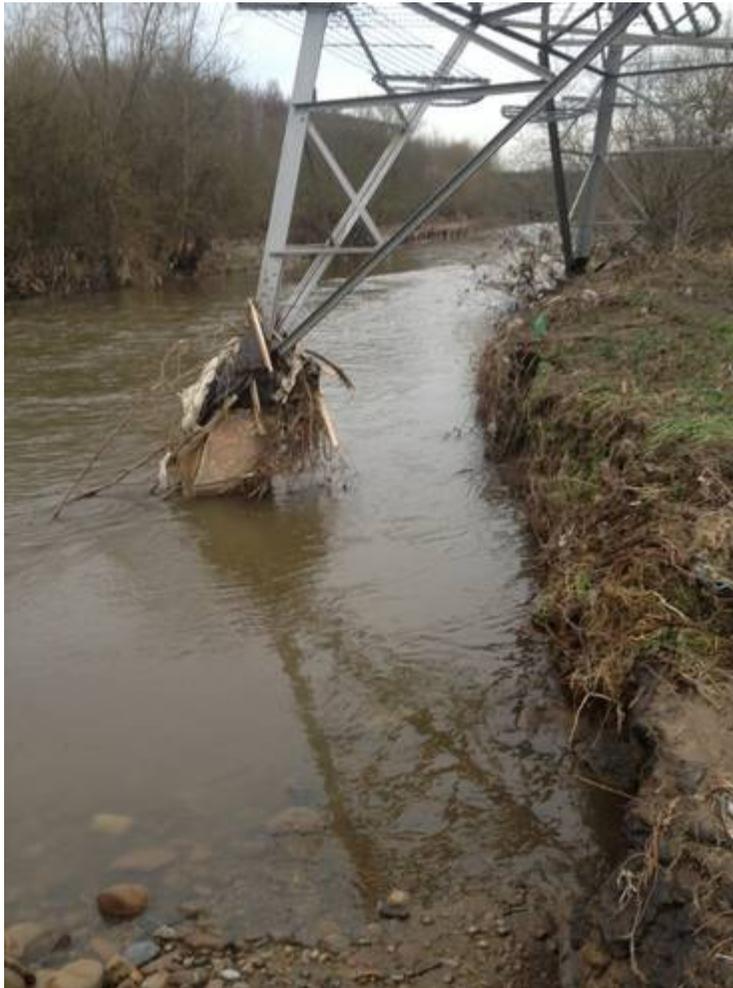
Eva - Tower VA25

- Route of River Irwell changed as a result of flooding
- Tower VA25 located in new course of river
- Tower foundations on land prior to Storm Eva
- If tower had failed, supplies to Bury Grid (64,339 customers) would have been lost
